**IN DEFENSE OF TREES ON EARTHEN DAMS
PARTICULARLY AT THE ARLINGTON RESERVOIR
Call for Further Research in View of Treed Dams
Holding up Through the Last 100 years of Storms!**

By Oakes Plimpton, Arlington Res Committee, Arlington, Mass.

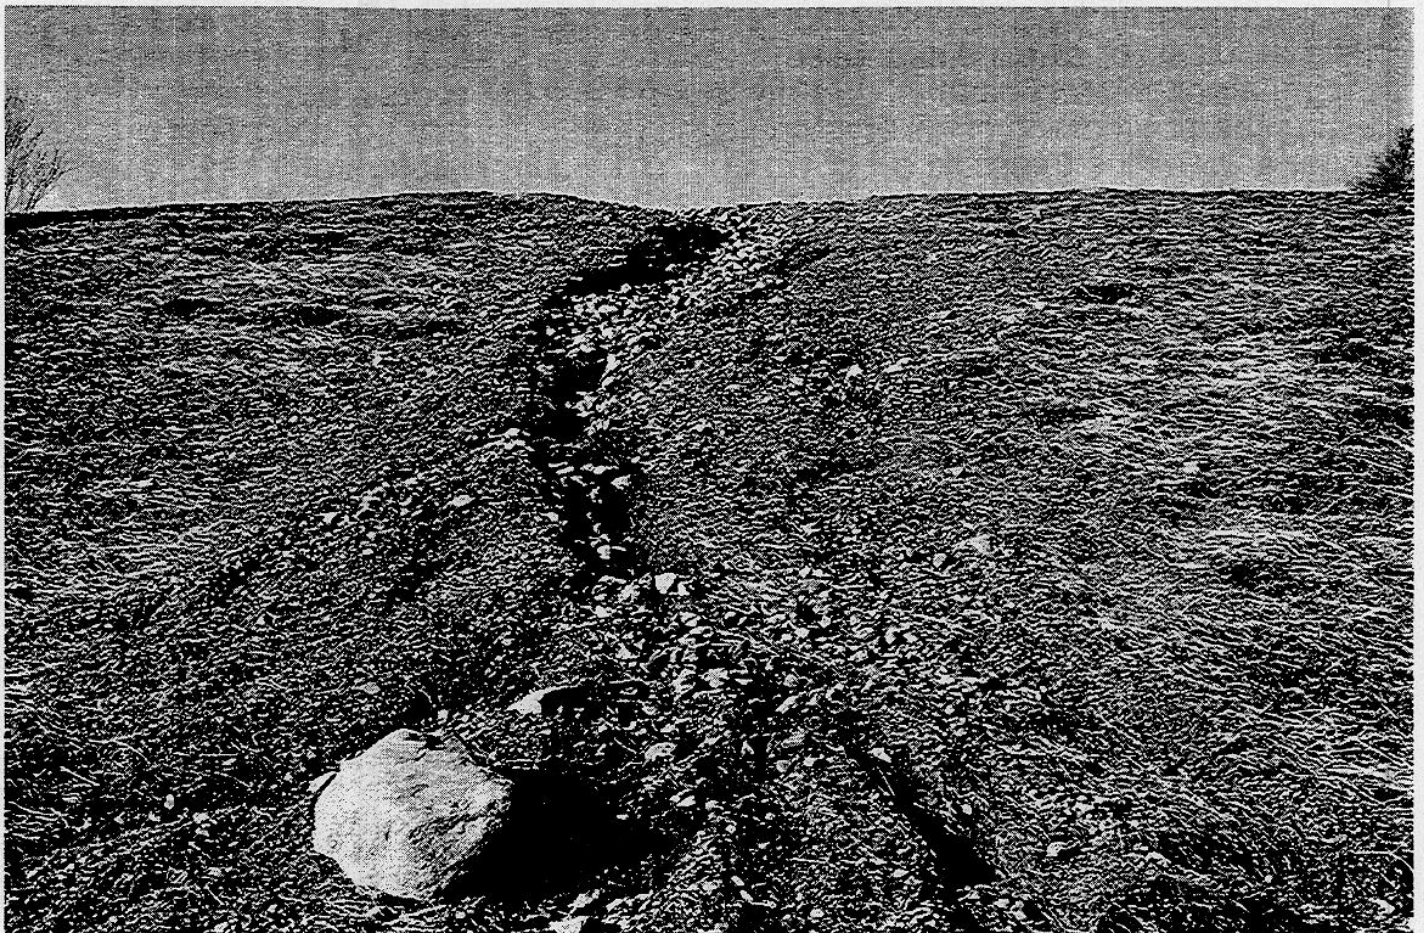
**Erosion on Boston Hill, Robbins Farm Park, Arlington
after October 1998 50 year Storm — None at Forested
Menotomy Rocks Park with Equal Slope Nearby**

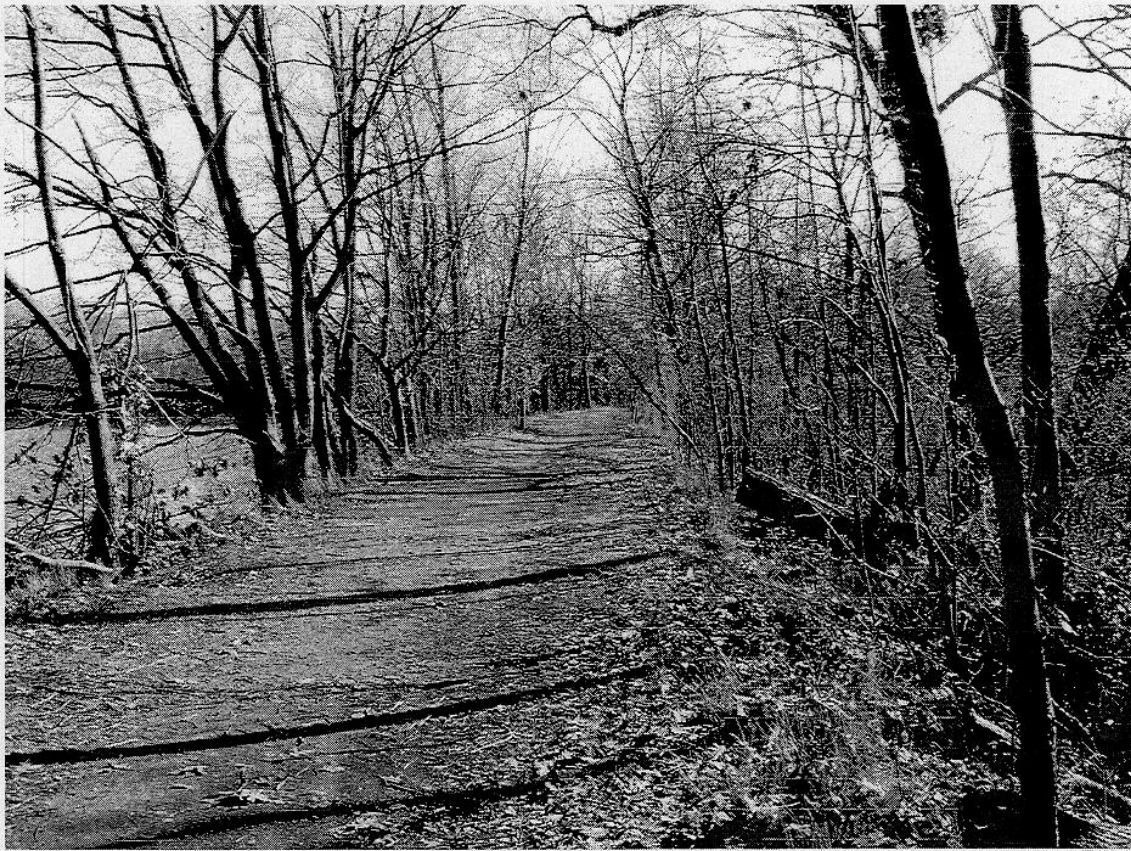
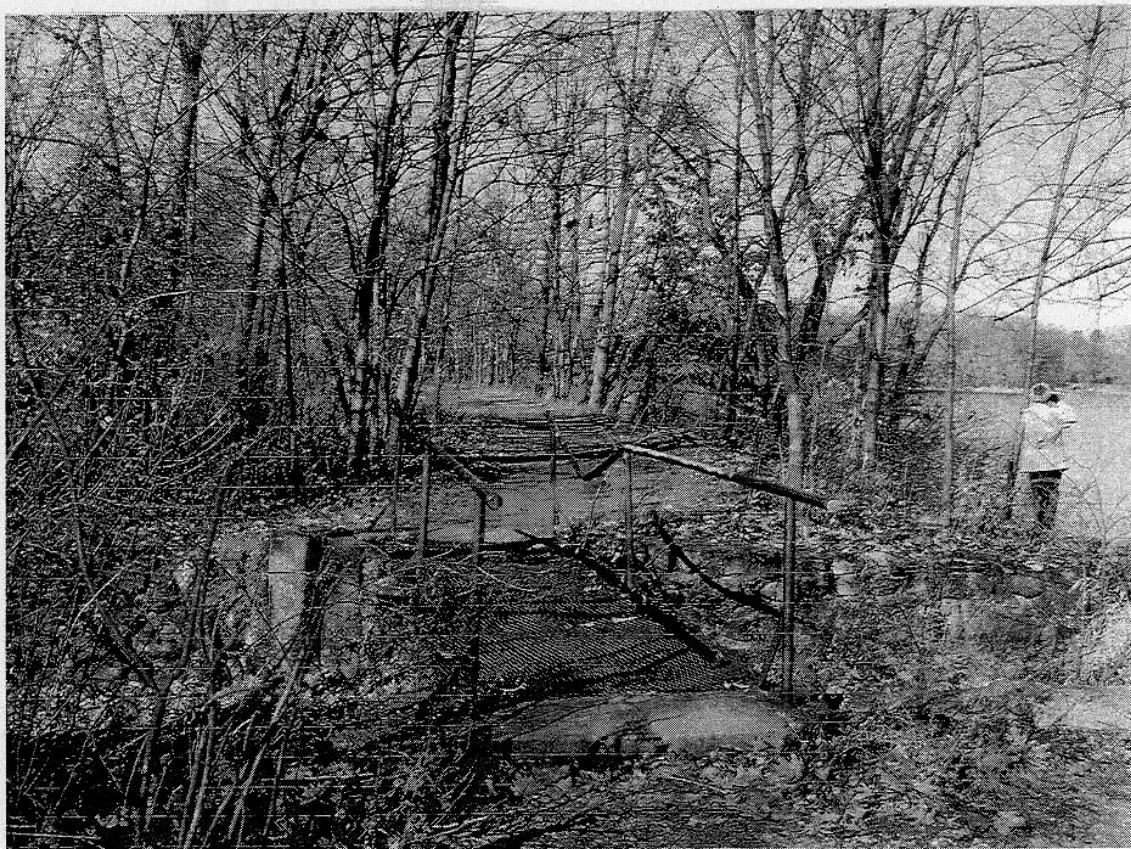
OUTFLOW OF THE RES AND THE EARTHEN DAM

Trees Buttress and hold together Earthen Dams; Arlington Reservoir Dam & many others have held 100 years.

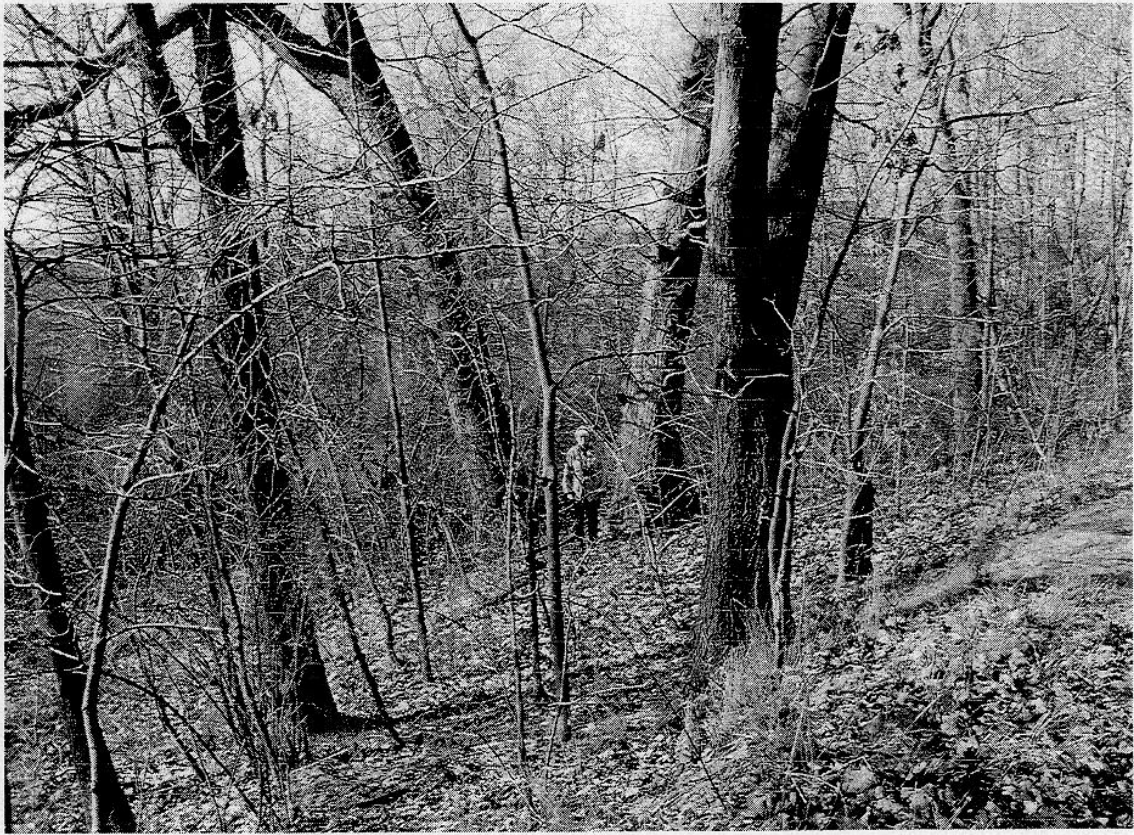
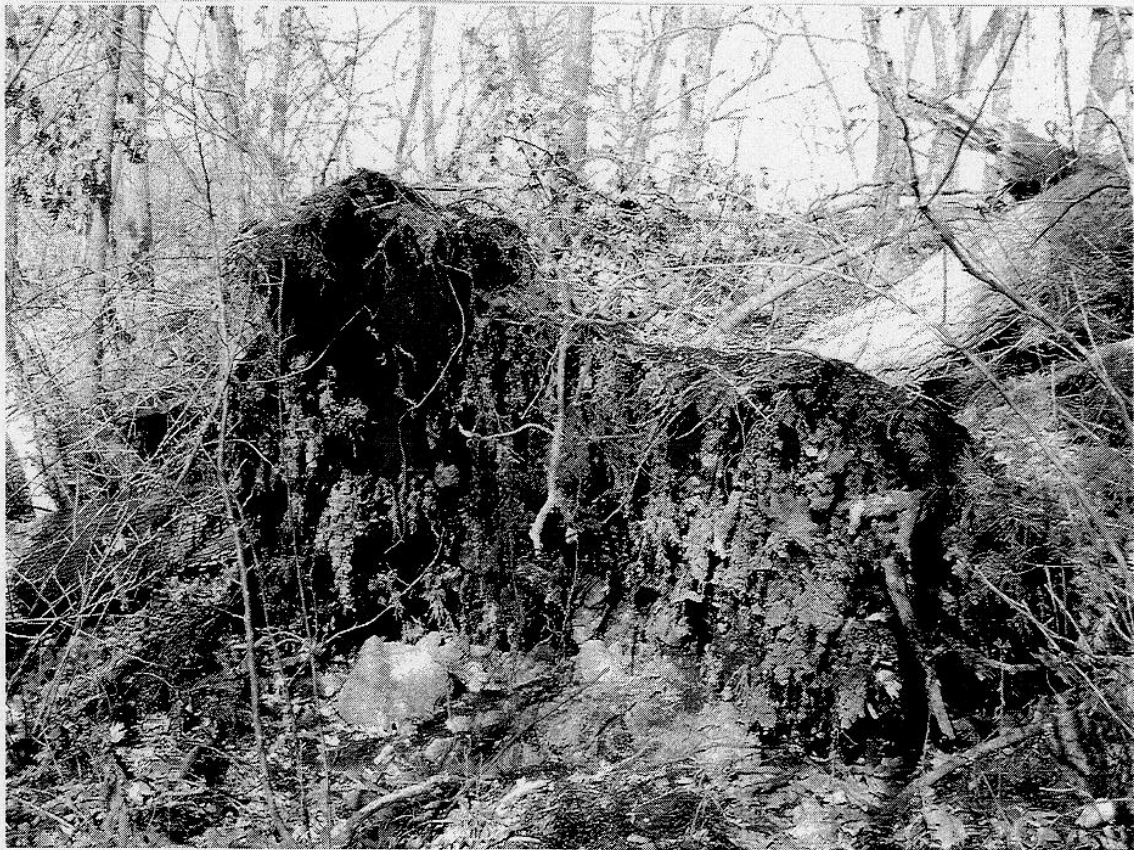
OK, what if a hurricane blows a tree down? A fair sized oak blew down at the Res in a recent storm, the roots not holding in the swamp. Note from the photograph that the rootball is mostly only a foot deep or less, and that the whole incident is incidental to the stability and integrity of the dam. If a tree dies, greater wicking happens, but in comparison with the size of the dam, again one tree or even several is insignificant. Few trees die, as they are so well supplied with water at that location. Note that at the Res, there are a number of good-sized oak trees growing on hillocks just outside the earthen dam itself which should not be cut down under any theory of tree removal.

FALLEN TREE; MATURE OAKS 15 FEET FROM DAM

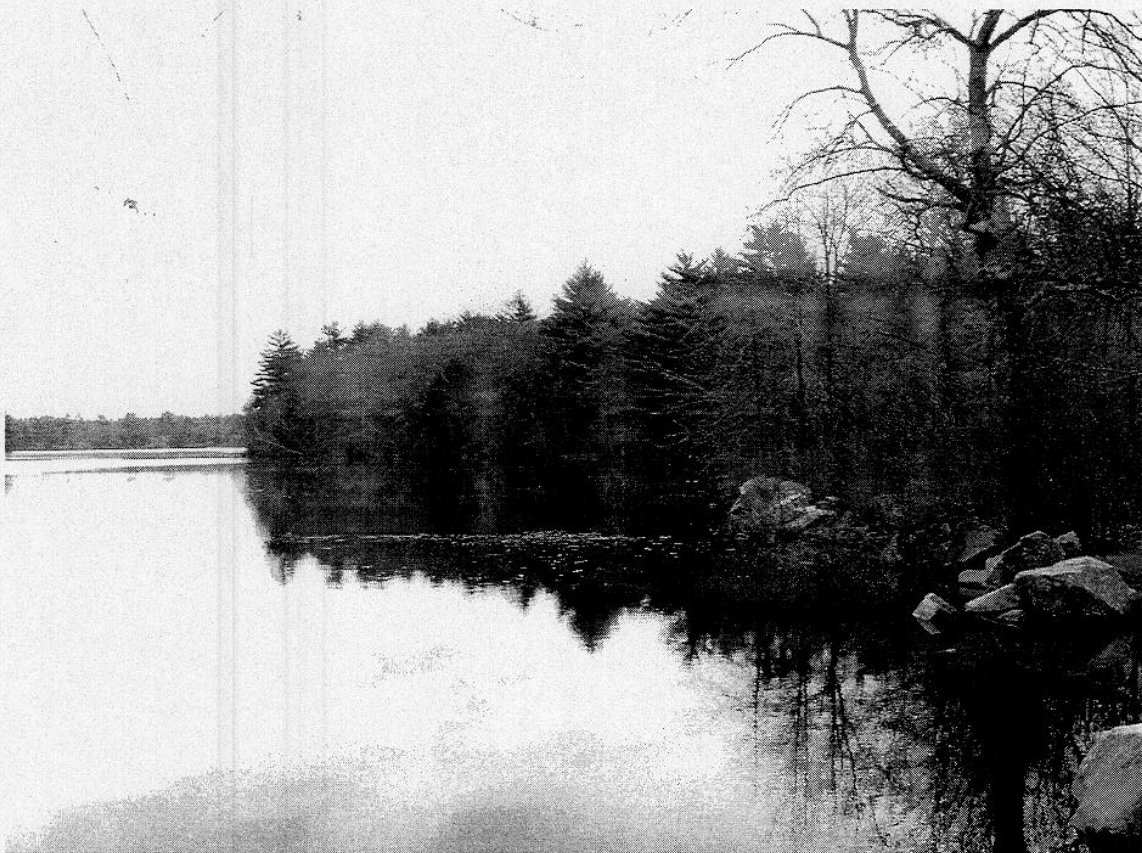
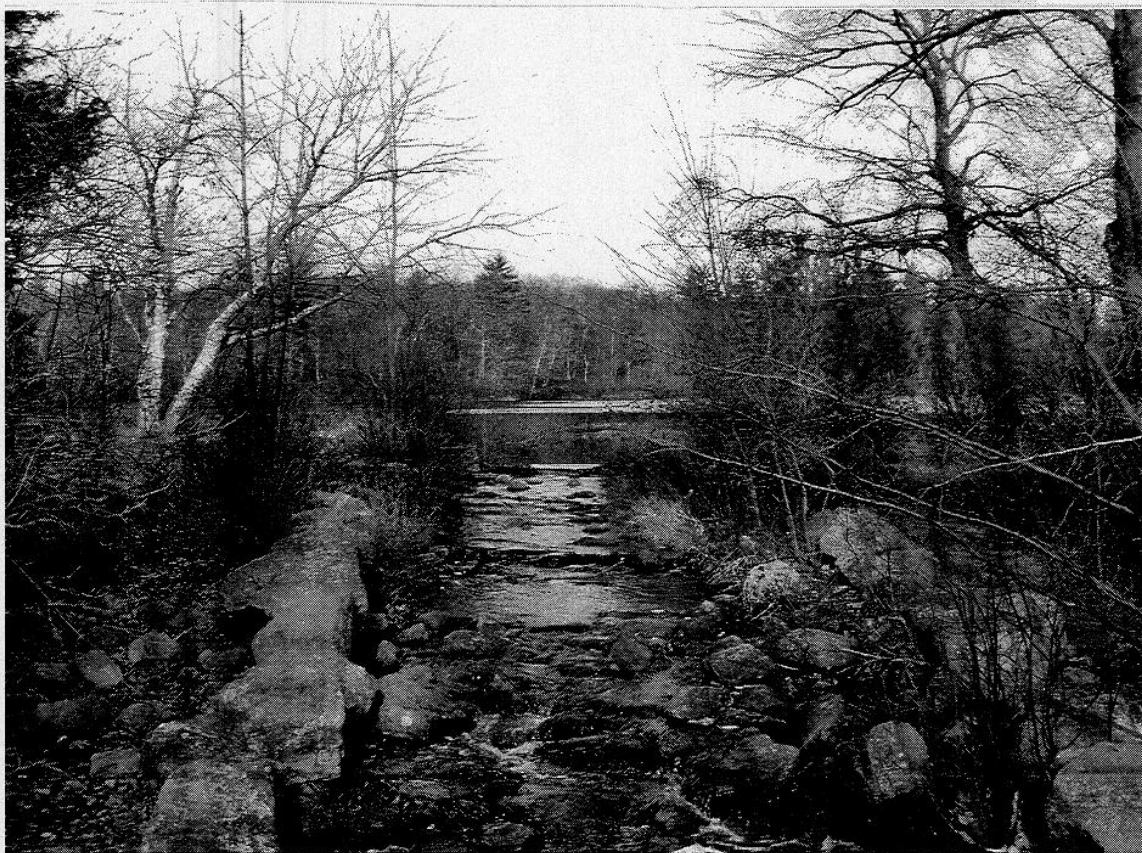
But even much smaller treed earthen dams have withstood the test of time. At Borderland State Park* in the town of North Easton, Leach Pond, a 200 acre shallow pond, is formed by a 300 yard earthen dam less than half the size of the Arlington Res dam, 8 feet across at the top, about 8 feet to the swamp, only 2 feet to the pond (the pond is higher on the dam), and that earthen dam has been there since General Leach dammed the pond for his iron works back in Colonial times! It is treed along its entire length with swamp maples interspersed with birch, oak and pine trees, with high bush blueberry bushes and swamp azalea growing along both sides. That dam withstood the 1938 Hurricane (which had flooding rains, and blew down perhaps a quarter of the maple and oak trees along its length), the twin hurricanes in 1956, more recently Hurricane Bob and some very heavy rain storms, as have the dams at the Res and the Mystic.

OUTFLOW AND EARTHEN DAM SHORE AT LEACH POND

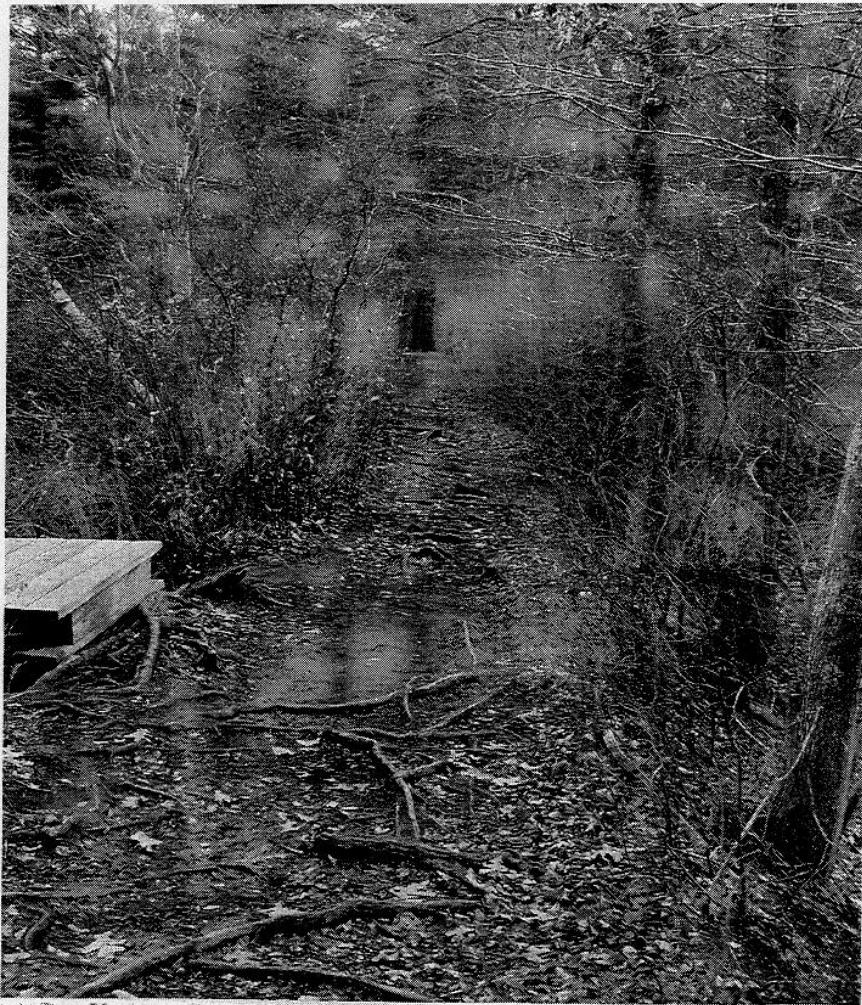
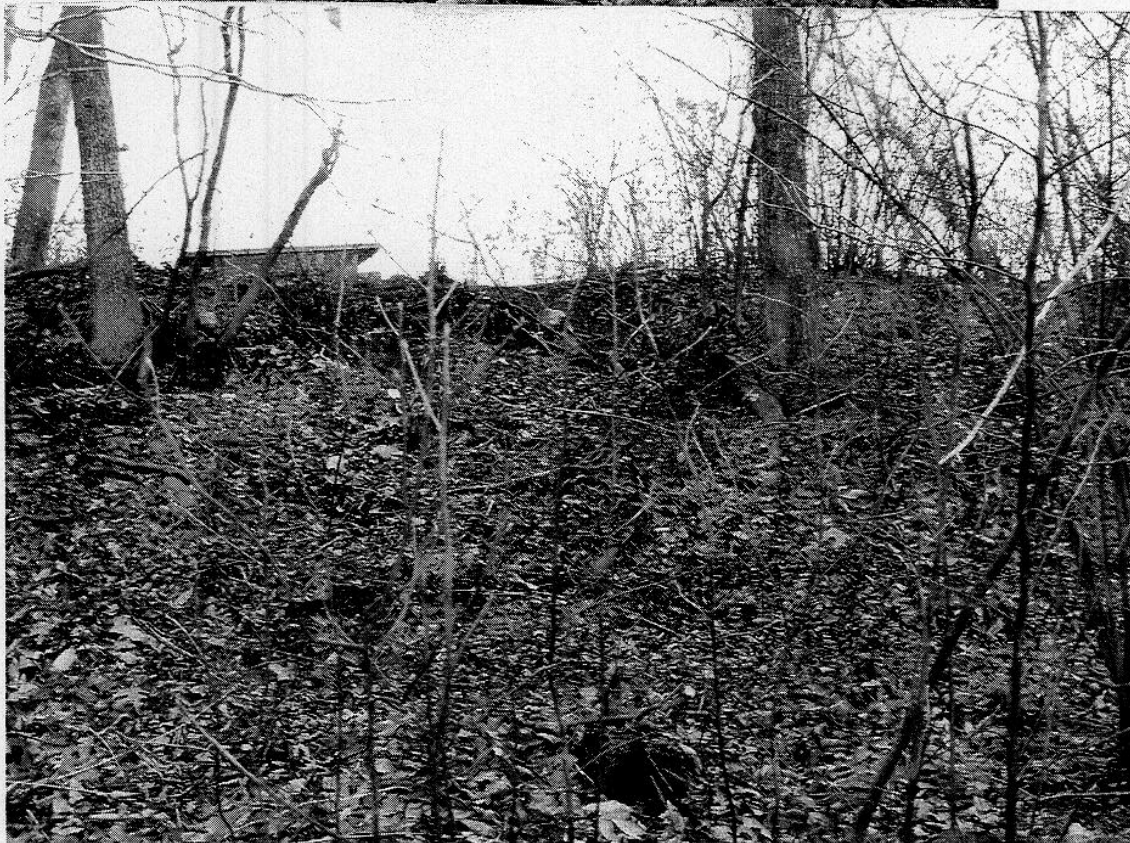
LEACH POND DAM SHOWING ROOTS & SWAMP SLOPE

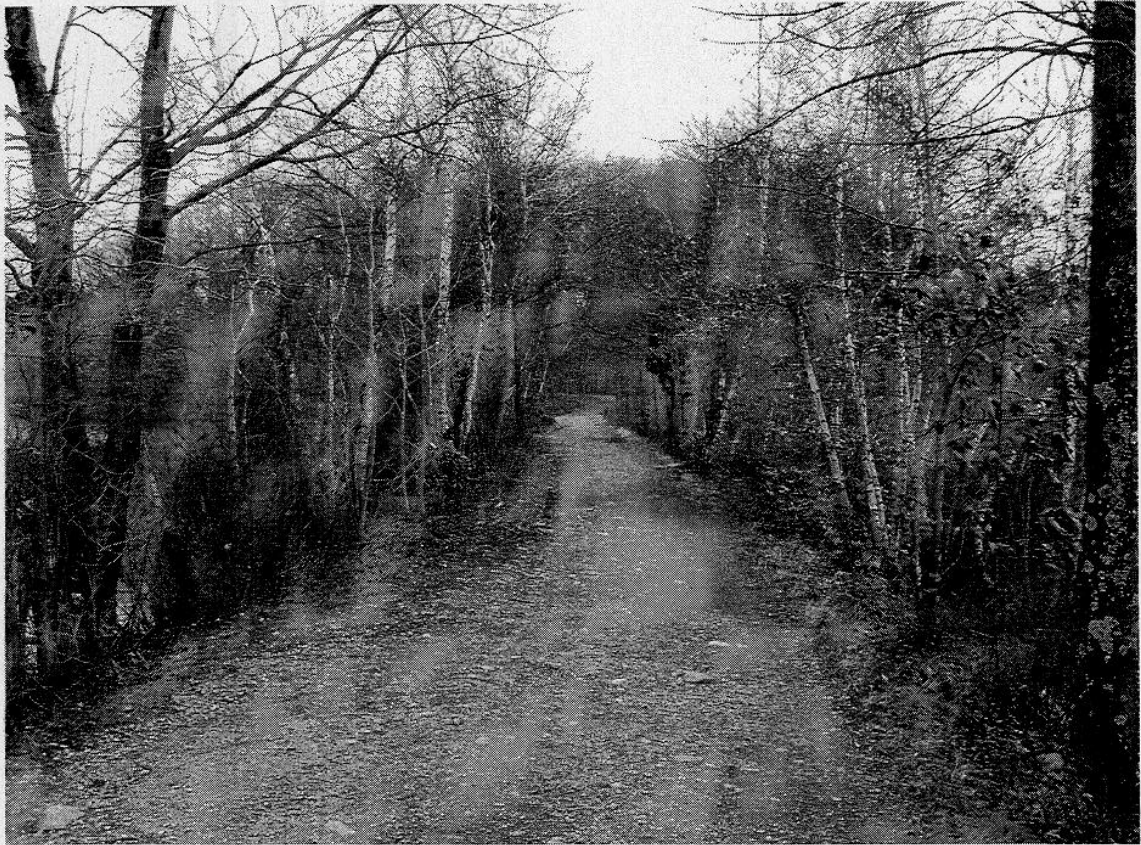
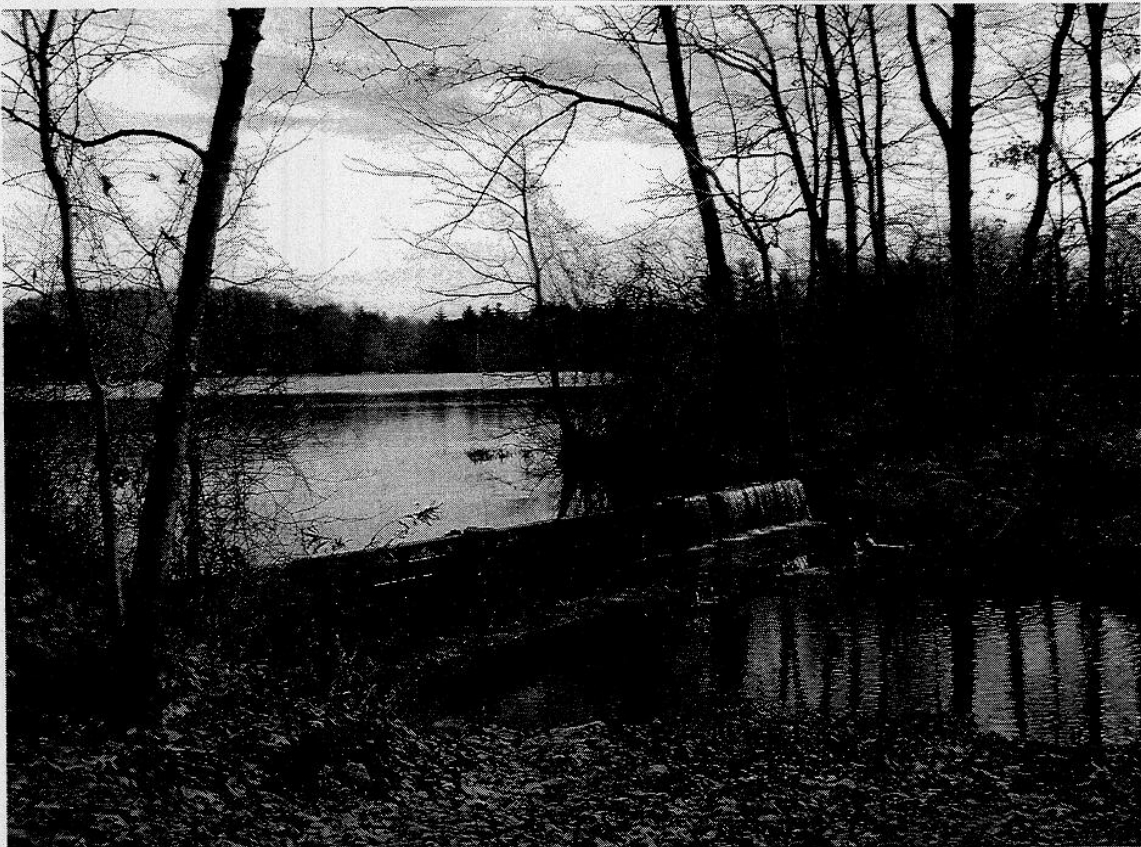
At Borderland Park there is another longer earthen dam connecting various islands to form Upper Leach Pond. That dam when still new and hence treeless, was breached twice in the 1940s by spring rains. Clay was added to the mix of fill to make the dam, and it has held fine since then — 60 years — now treed all along its length with birch and aspen. That dam measures 12 feet on the top, 8 feet to the swamp side, 2 feet to the pond (again the pond comes up much higher on the dam than at the Res), and is about five feet high on the swamp side.

UPPER LEACH POND OUTFLOW AND EARTHEN DAM
